IN no.: **IN-153 rev 1.0**

Date: **2021-12-14**

Device affected: **nRF52805-CAAA**

Device version / Build Code: **Ax0**

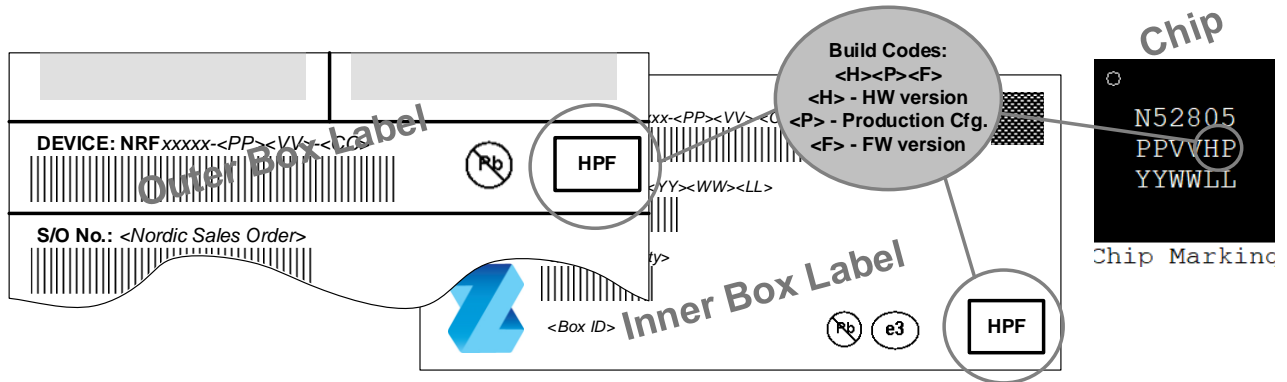
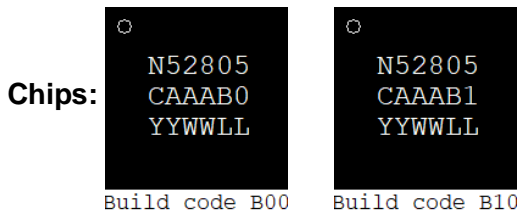
**Marking/Shipping labels:**

Build code – Bx0
