nRF7002

Revision 1

Errata

v1.4

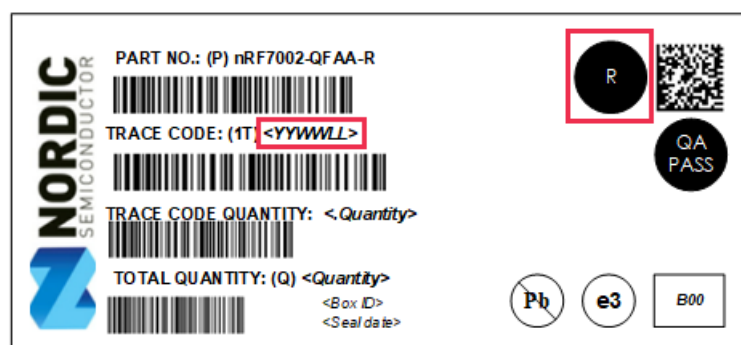
- For trace codes earlier than 2333xx (year 2023, week 33) with or without a black R sticker on the reel, vacuum bag, and inner box label and nRF Connect SDK version earlier than 2.5.0, the TX output power can vary by up to ± 3 dB. The device might operate outside the specified TX EVM limits.
- For trace codes earlier than 2333xx (year 2023, week 33) without a black R sticker on the reel, vacuum bag, and inner box label and nRF Connect SDK version 2.5.0 or later, the TX output power can be up to 3 dB lower than specified.

Figure 1: Trace code and black R sticker on nRF7002 label

- Use devices with trace codes earlier than 2333xx (year 2023, week 33) with a black R sticker on the reel, vacuum bag, and inner box label and nRF Connect SDK version 2.5.0 or later.
- Use devices with trace codes 2333xx (year 2023, week 33) or later and nRF Connect SDK version 2.5.0 or later.
