nRF21540 Engineering A

Errata v1.0

This Errata document contains anomalies for the nRF21540 chip, revision Engineering A (QDAA-EA0).

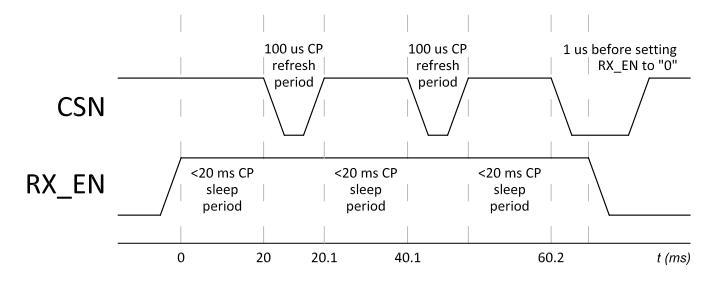
Figure 1: SPI write configuration example

Internal clock spurs appear in the TRX output.

The device is in the Receive state.

Some RX channels have degraded sensitivity of approximately 5 dB.

The internal charge pump (CP) clock source can be halted by toggling the CSN signal in the Receiver state. The CSN high period should be less than 20 ms, and the CSN low period should be 100 μ s.

The workaround can be used in temperatures below +65°C.
